# Manhole Inspection Summary

Manhole # S23EE1003MH

Insp Date: **2/22/07 2:23 PM**

**Location** Address: **1425 41ST ST**

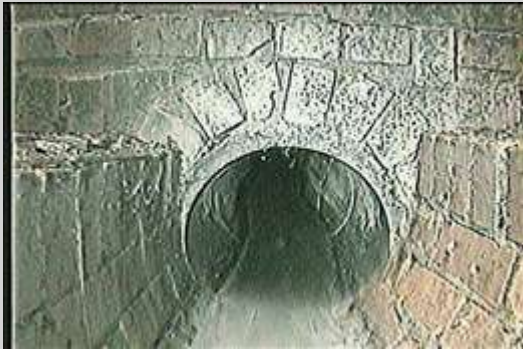
### 12 in. Circular Gravity Sewer Pipe Out @ 12 O'Clock

Pipe Material: **Clay** ☐ Pipe Lined

Invert Depth: **10.79** (ft.) Flow Characteristics: **Fast**

Deposits: ☒ None ☐ Mud ☐ Sludge ☐ Debris ☐ Grease

Infiltration: **None** Pipe Seal Cond: **Unknown**

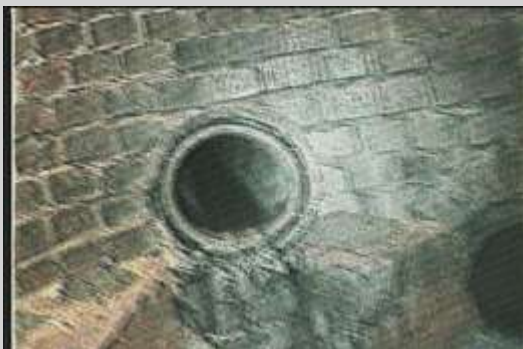
### 8 in. Circular Gravity Sewer Pipe In @ 4 O'Clock

Pipe Material: **Clay** ☐ Pipe Lined

Infiltration: **None** Pipe Seal Cond: **Unknown**
